The Parity Projects' rehabilitation programme:

The rehabilitation programme set up by Parity Projects included conventional renovation work along with specific eco-measures.

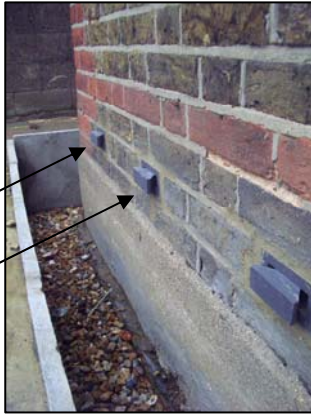
Damp proofing of the front wall: For a long time before the house was bought, the high external ground level had allowed settled rain water to seep horizontally into the front wall lower parts, causing damp problems. Moreover, internal skirting of the ground floor were above the floor line, therefore covering the air bricks and adding to the problem by preventing proper ventilation below the floorboards.

During the rehabilitation, the external ground level adjacent to the house has been lowered by digging a **gravel-filled drainage ditch** deeper than the damp proof course. Rainwater is now diverted in the trench and soaks away via **tubes** pushed deep into the ground below, avoiding the vulnerable wall face.

To **speed up the natural drying process** of the front wall in an environmentally harmless way, a **specific air flow system** – based on specific brick's air chambers and temperature variations- has been installed and has already helped in measurably reducing the wall moisture levels¹.

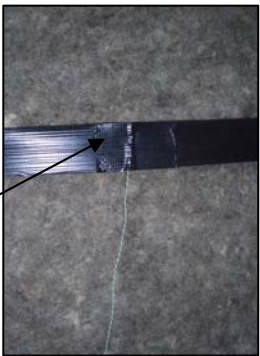
Thermal sensors have been installed within the walls throughout the property to monitor the performance of the various insulation materials in use. Thermocouples were also put in the living room's concrete slab to monitor its in-use performance.

Temperature readings are taken **at 5 minutes intervals** and stored using a **data logging system designed in-house**, potentially replicable for other homes. Once the project is completed the data collected will be available from the **Parity Project website**.
