**RIVER CHANNEL PLANFORM CHANGES IN UPLAND SCOTLAND
: WITH SPECIFIC REFERENCE TO CLIMATE FLUCTUATION AND
LANDUSE CHANGES OVER THE LAST 250 YEARS (VOL. II)**

Lindsey Jo McEwen

**A Thesis Submitted for the Degree of PhD
at the
University of St. Andrews**

1986

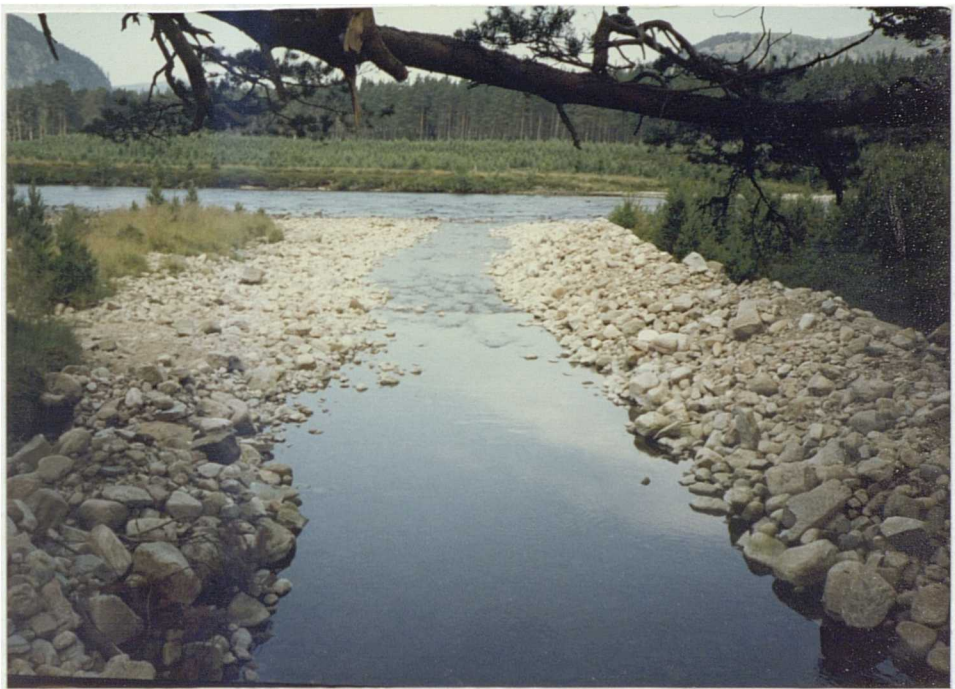
Plate 6.2.(ii)

The bulldozed lower reaches of the Garbh Allt

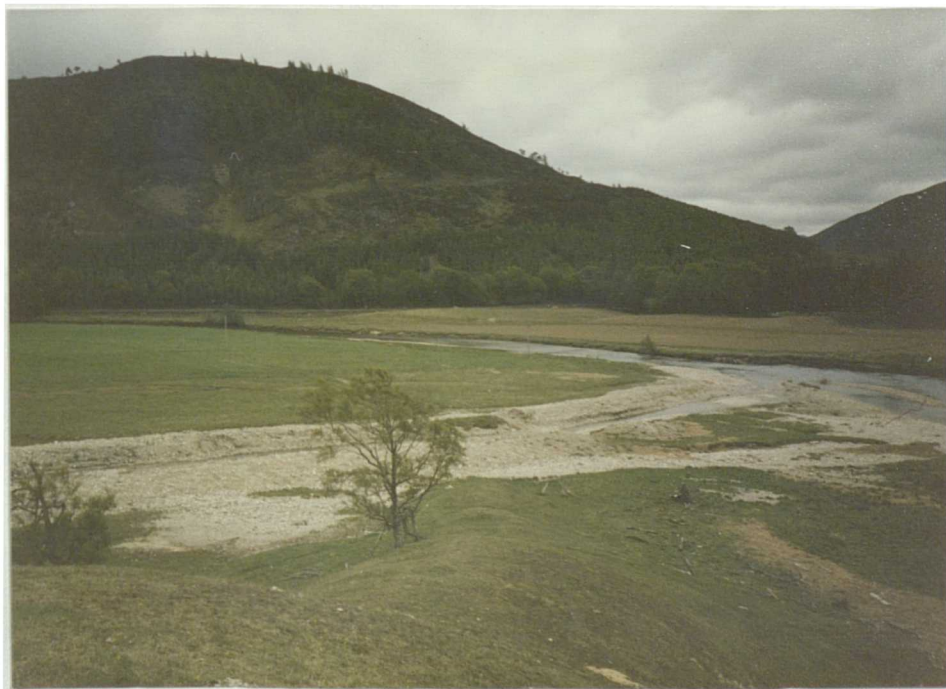
Before: in June, 1983 (with evidence of earlier artificial removal of
sediment from the channel)

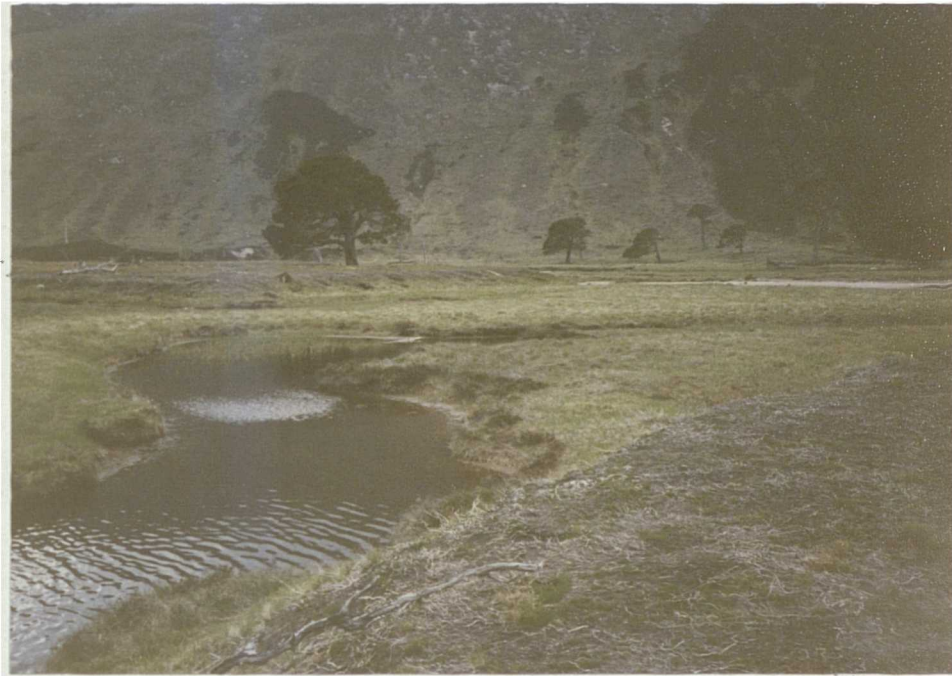
Tortuous palaeomeanders distant from the present channel
in Glen Derry

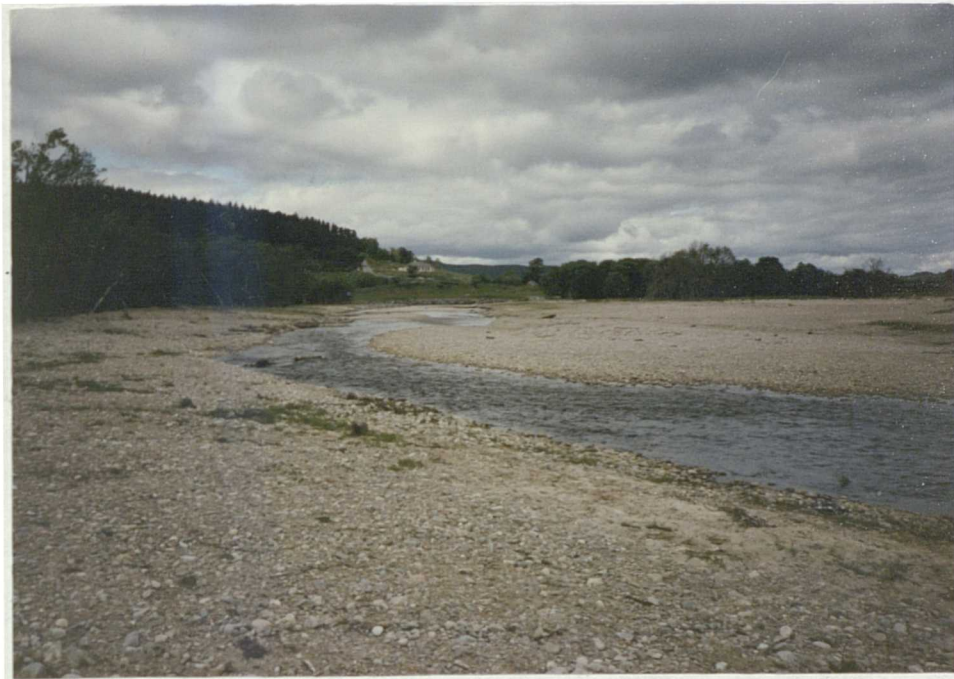
Plate 7.3.2.(i)

The lower Nethy fan before its confluence with the River Spey.
A wide area of unvegetated flood sedimentation exists, relating
to the flooding of Sept, 1981.

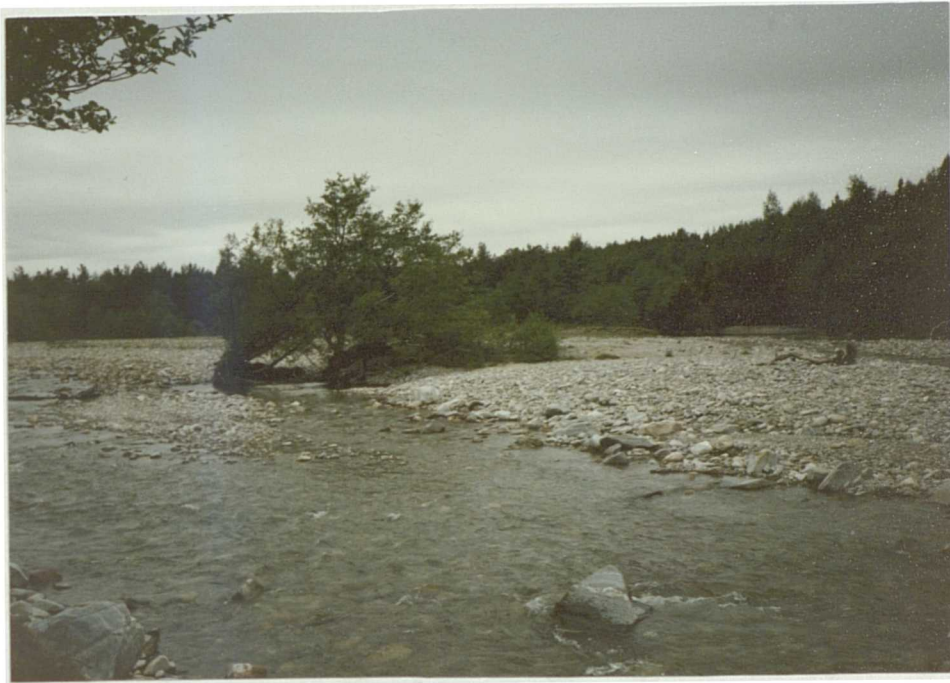
plate 7.3.4.(i)

The wide, braiding channel of the River Feshie near Lagganlia

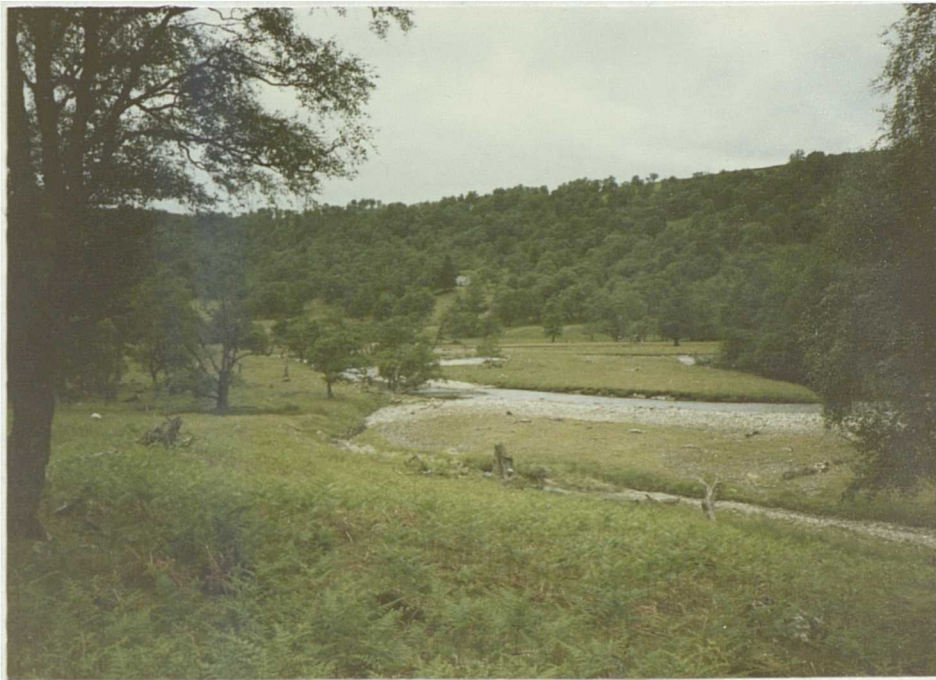
Plate 7.3.5.(i)

A sinuous planform (formerly around occasional stable bars) on the middle Tromie
A more recent flood channel is evident in the foreground.

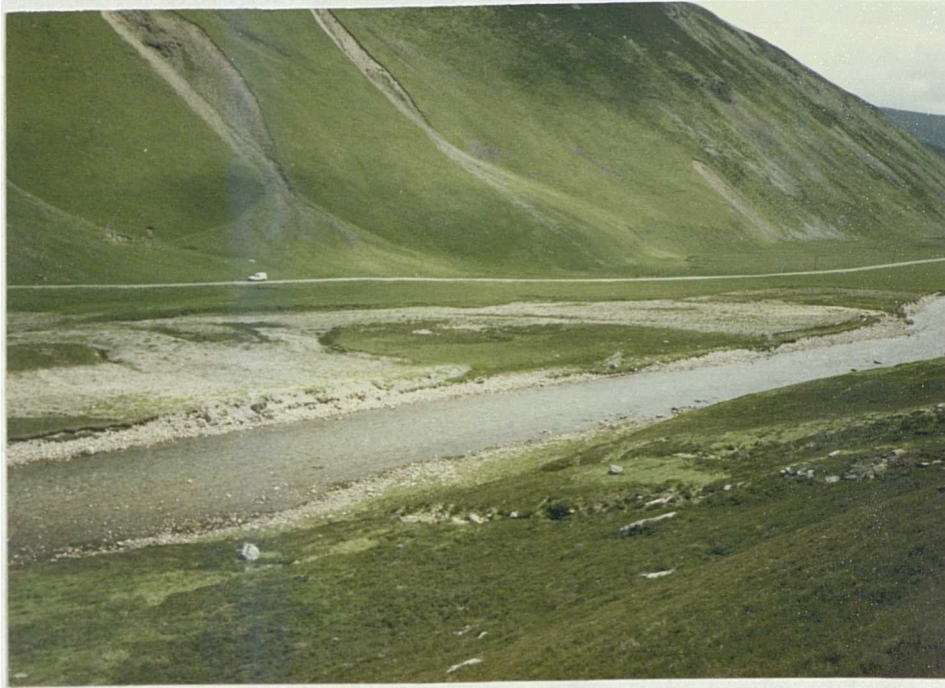
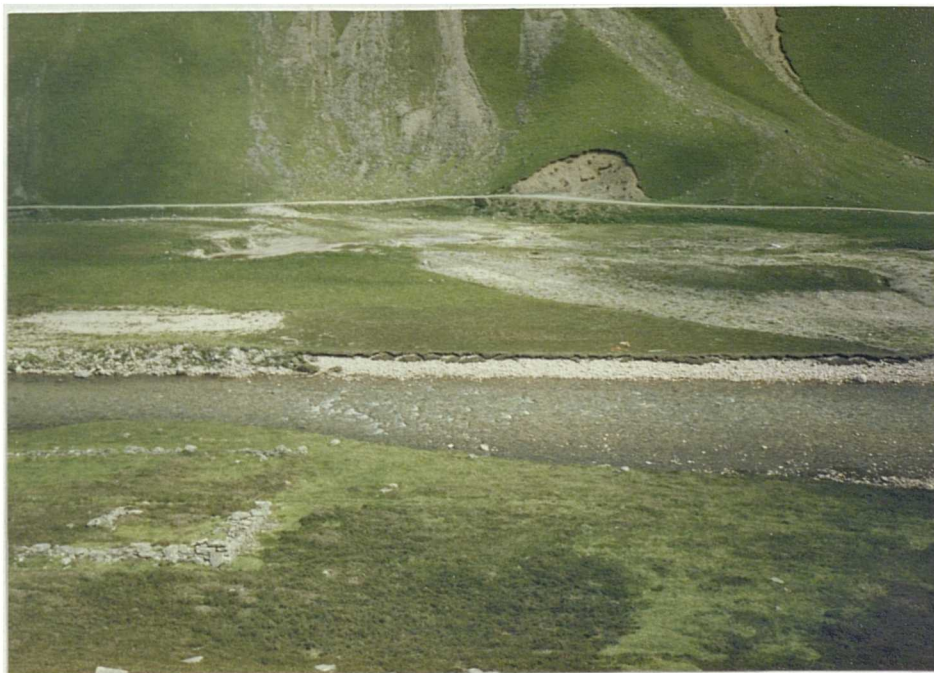
The Avon at Foals Craig, showing former channels (1869 and 1900)
and former basal erosion of tributary fan deposits

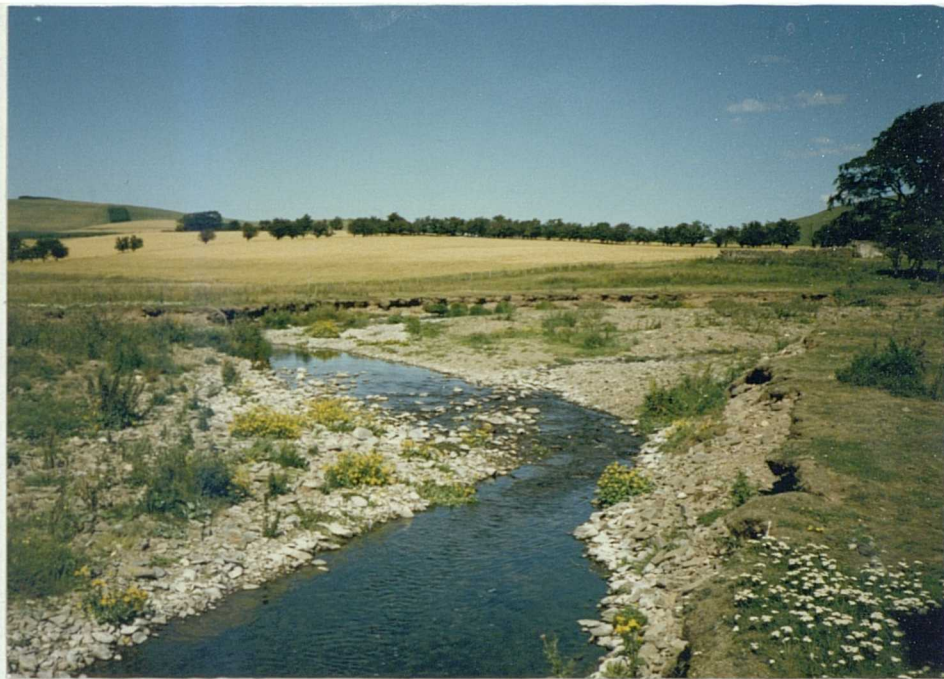
Plate 7.4.3.(i)

Restabilisation of both lateral and medial bars on the Cleekhimin Burn

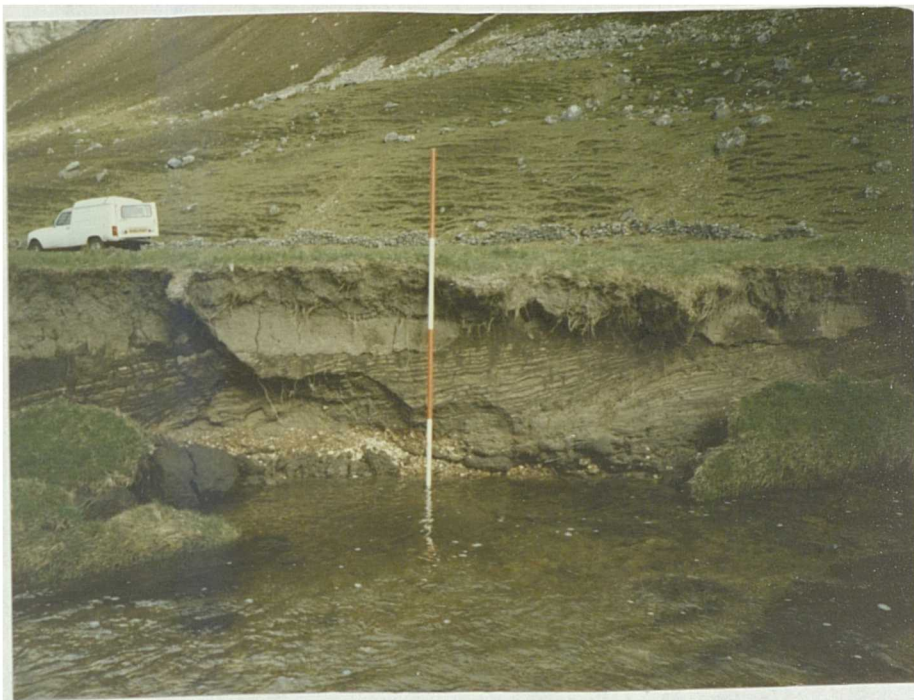
Shear banks with high silt-clay ratio on the upper Ey

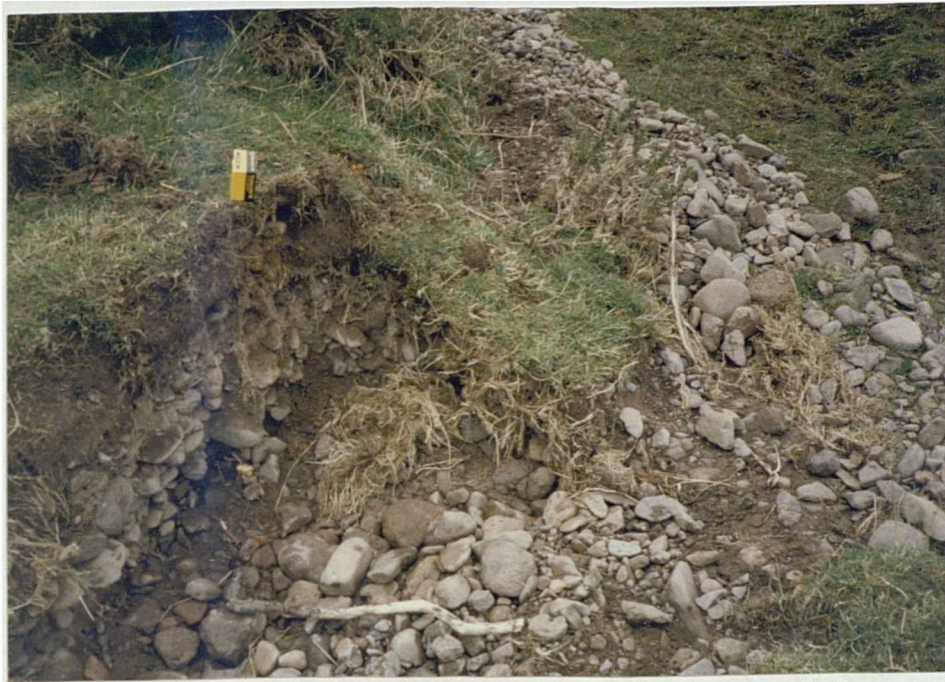
Unstable bank composed of layers of reworked till deposits,
inter-layered with finer flood sedimentation.
